Monitoring Data Record

Project Title: I-2511CB (I-85 Widening) COE Action ID: 200221534
Stream Name: Town Creek (Site 5) DWQ Number: 040271
City, County and other Location Information: Rowan County, I-85 Widening (-TI-PINC Sta. 20+35)
Date Construction Completed: Water turned on 12/6/06, Stream reforestation completed 12/13/06
Monitoring Year: (4) of 5
Ecoregion: _____ 8 digit HUC unit 03040103
USGS Quad Name and Coordinates: _____

Year 4 Summer – June 2011

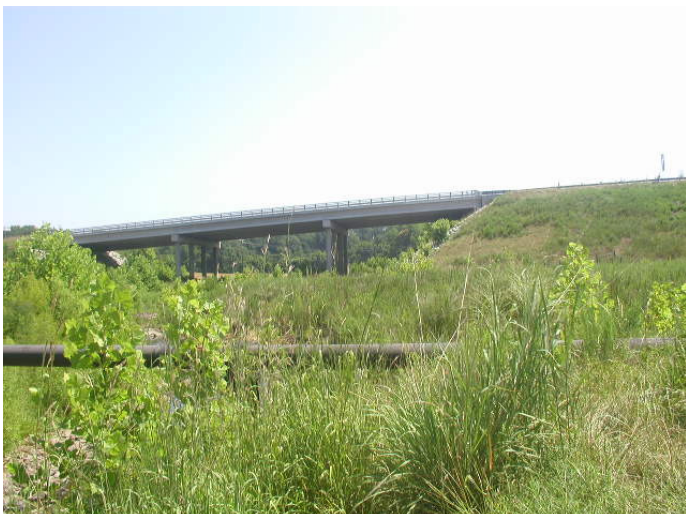
(Overview looking downstream of buffer area)

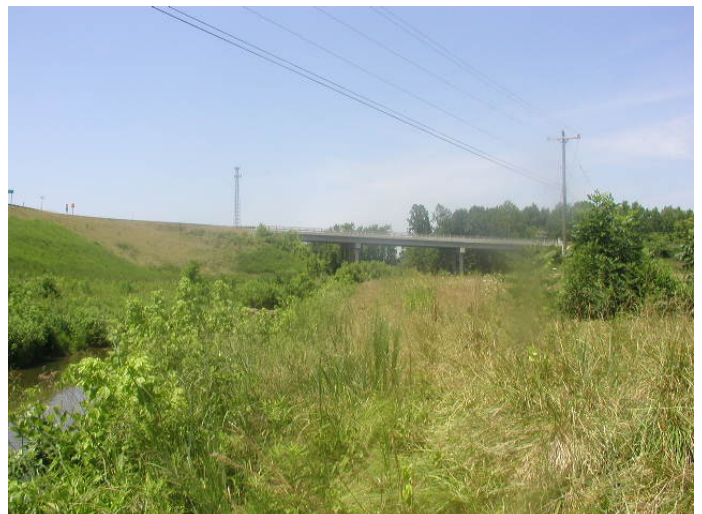
(Overview looking upstream of buffer area)

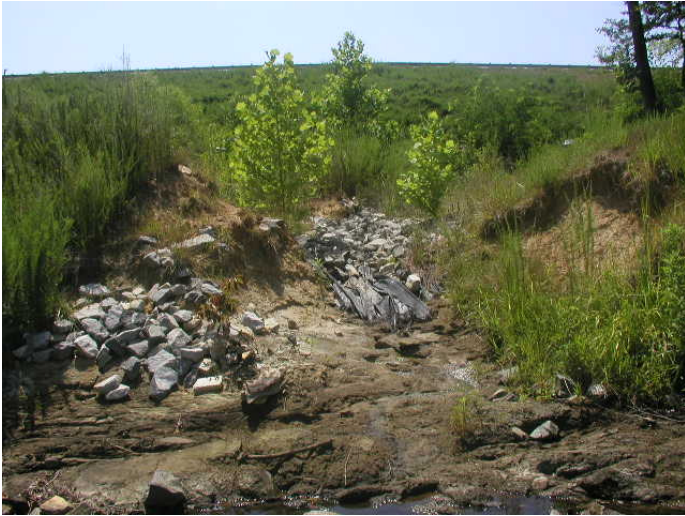
The Town Creek stream relocation is stable for the Year 4 Summer evaluation, except for some bank erosion on the left bank in front of a rock vane at Sta. 16+50 just upstream of the bridge crossing. Some bank erosion was also noted on the right bank at Sta. 13+00 where a drainage ditch exits into the stream relocation. The bank erosion on the right bank at Sta. 13+00 has been noted previously and has seen little or no change since originally noted. NCDOT live staked the eroded areas in March 2010 to help stabilize the banks but the live staking has not stabilized the area.

| Bank or scour erosion present? | Bank erosion on right bank | Bank erosion on left bank | | | |

Erosion on right bank @ -TI- PINE Sta. 13+00

A site visit was conducted on May 5, 2011 with the regulatory agencies and NCDOT personnel present. It was determined at that meeting that repairs of the left hand bank just upstream of where the bridge crosses was needed. NCDOT plans to use the rock from the rock vane that was installed to construct the toe protection. The bank above the toe protection will be graded at a 3:1 or flatter slope. NCDOT will also plant the repaired area with live stakes during the next planting window (November 15 to March 15). NCDOT will continue to monitor this stream relocation.

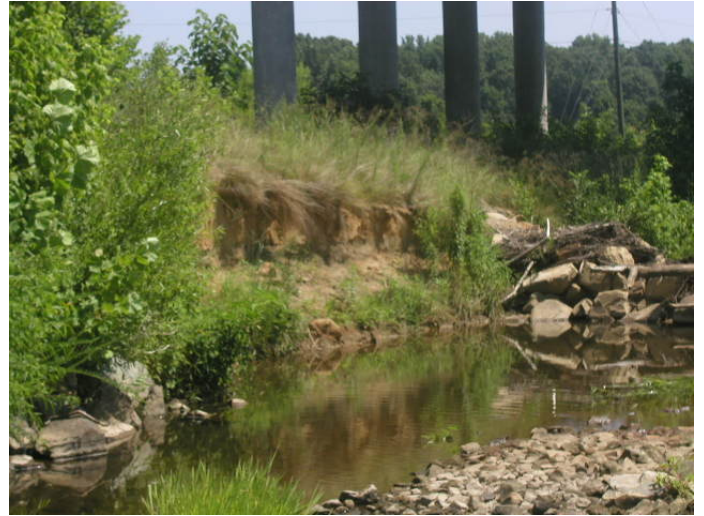
Erosion on left bank @ -TI- PINE Sta. 16+50
